# Gallery Walk Toilets, Scenic Rim Region, QLD

## *Upgrade of a failing system for toilet reuse*

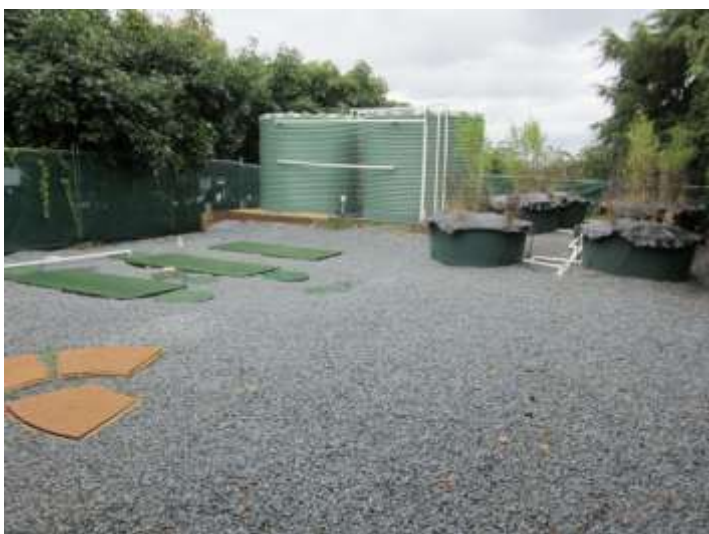
**An Orenco AX60 textile filter, multiple-barrier disinfection process and captive dispersal system has replaced the failing sand filter at Gallery Walk**

Rather than replacing the media in the existing sand filter, the solution proposed was an entirely new system, utilising where possible existing infrastructure but with entirely new treatment elements. A three-stage solution was installed by Alliance Water Solutions;

- Passive primary treatment using the existing treatment tanks
- Secondary treatment through Orenco's AdvanTex textile filters
- Quadruple-barrier disinfection with membranes, ozone, chlorination and UV for full public health protection.

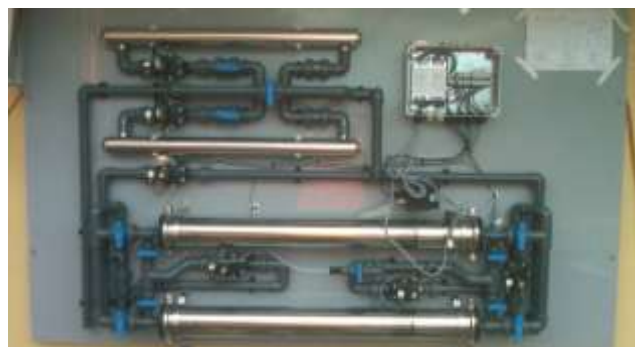
**A 4-stage disinfection process has been developed at Gallery Walk for Class A+ reuse**
